**Flood Control Project Maintenance  
Levee Inspections**

**Spring 2013 Levee Inspection Results**

**Reclamation District No. 0556 Upper Andrus**

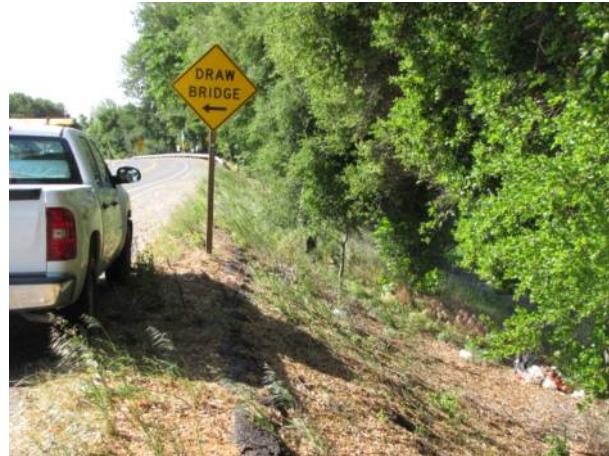
Levee Mile Report Line	4
Start Levee Mile	0.17
End Levee Mile	0.42
Location	Land Side
Category	
Item	Vegetation
RD 556 Unit 1 looking downstream from levee mile 0.17 landside slope. Photo taken 4-25-2013.	
phillips_s_20130509_415.JPG

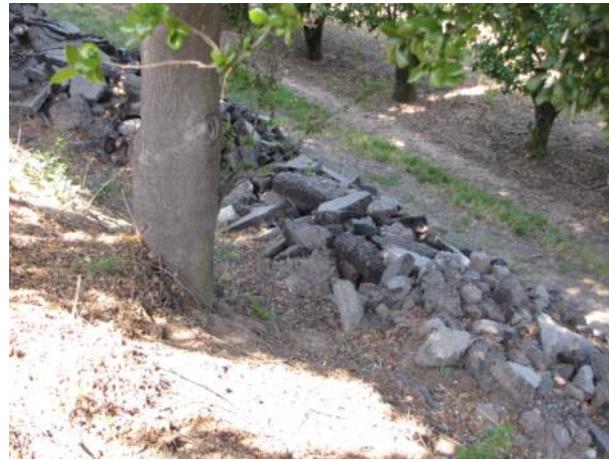
DWR ID: DWR_RD0556_01_f_2012_37				
19	1.34	1.36	Encroachments	LS U	DE : Debris En Inspector Comments: Asphalt dumped along toe of levee. Photo No.75. 4-25-2013.		38.227521 °	38.227320 °	27	-121.532393 °	-121.532710 ° Y
							DWR ID: DWR_RD0556_01_s_2013_27				
20	1.36	1.37	Trim / Thin Trees	LS M	T2 : Thin trees to allow visibility of the ground and room to flood fight. Ma		38.227320 °	38.227216 °	29	-121.532707 °	-121.532870 °
							DWR ID: DWR_RD0556_01_s_2013_29				
21	1.39	1.39	Erosion / Bank Caving	LS M	E1 : Note and monitor erosion site. Ma		38.227016 °	38.227016 °	21	-121.533105 °	-121.533105 °
							DWR ID: DWR_RD0556_01_f_2012_21				
22	1.41	1.72	Vegetation	LS M	V1 : Control annual grass and weeds on the levee slopes Ma and easements.		38.226785 °	38.224251 °	30	-121.533314 °	-121.537723 °
							DWR ID: DWR_RD0556_01_s_2013_30				
23	1.43	1.43	Erosion / Bank Caving	LS M	E1 : Note and monitor erosion site. Ma		38.226537 °	38.226537 °	40	-121.533512 °	-121.533512 °

Levee Mile Report Line	19
Start Levee Mile	1.34
End Levee Mile	1.36
Location	Land Side
Category	
Item	Encroachments
Unauthorized asphalt dumping on toe of levee section. Photo taken 4-25-2013.	
phillips_s_20130509_416.JPG

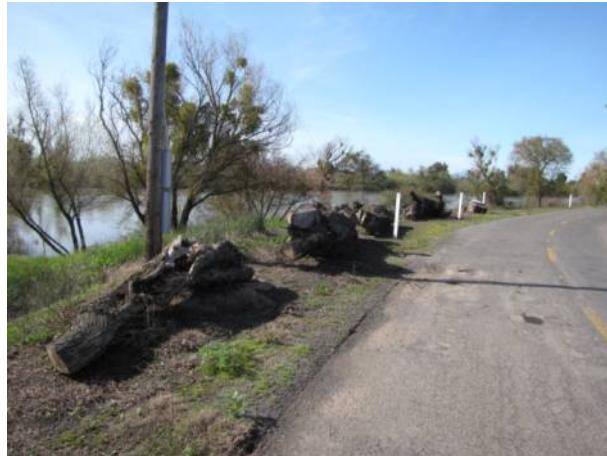
Levee Mile Report Line	25
Start Levee Mile	1.55
End Levee Mile	1.57
Location	Water Side
Category	
Item	Encroachments
<p>The land owner stated that he would have these trees removed from levee section next month (April). Photo taken 3-29-2011. 10-02-2012 The cut up tree has not been removed from waterward levee shoulder. NO CHANGE 4-25-2013.</p> <p>phillips_s_20130325_321.jpg</p>

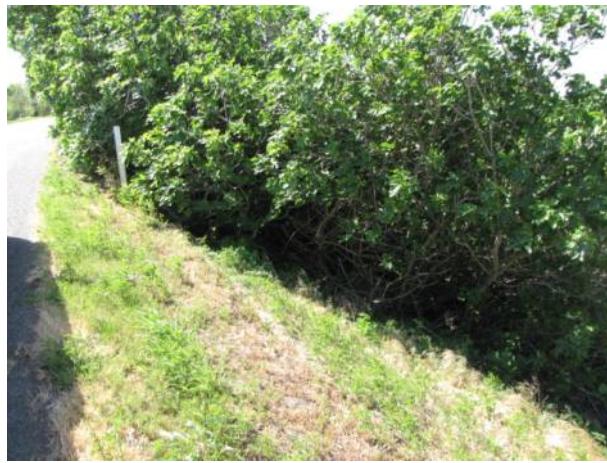
Levee Mile Report Line	32
Start Levee Mile	2.32
End Levee Mile	2.34
Location	Land Side
Category	
Item	Trim / Thin Trees
<p>levee mile 2.35 the fig trees are blocking view of slope landward. Photo taken 4-25-2013.</p> <p>phillips_s_20130509_417.JPG</p>

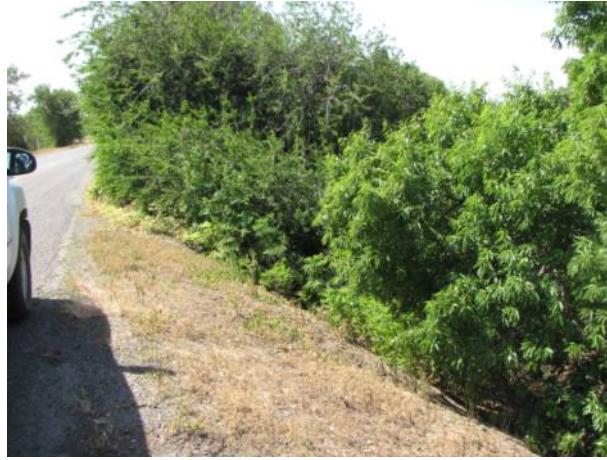
Levee Mile Report Line	35
Start Levee Mile	2.42
End Levee Mile	2.46
Location	Land Side
Category	
Item	Vegetation
<p>Levee mile these trees block view of levee section landward levee mile 2.42. Photo taken 4-25-2013.</p> <p>phillips_s_20130509_418.JPG</p>

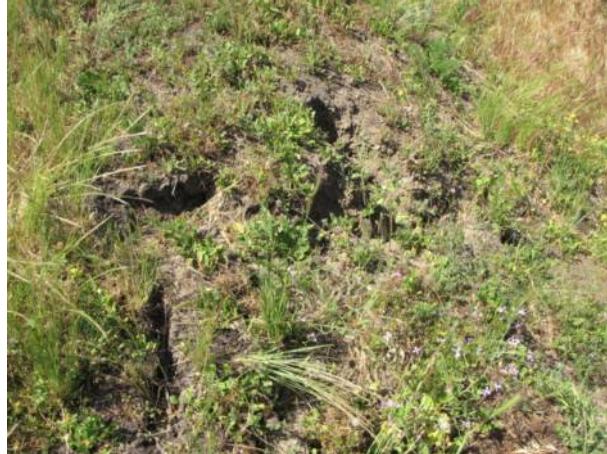
Levee Mile Report Line	56
Start Levee Mile	3.26
End Levee Mile	3.26
Location	Land Side
Category	
Item	Animal Control
This damage was caused by gophers in levee slope. Photo taken 4-25-2013.	
phillips_s_20130509_419.JPG

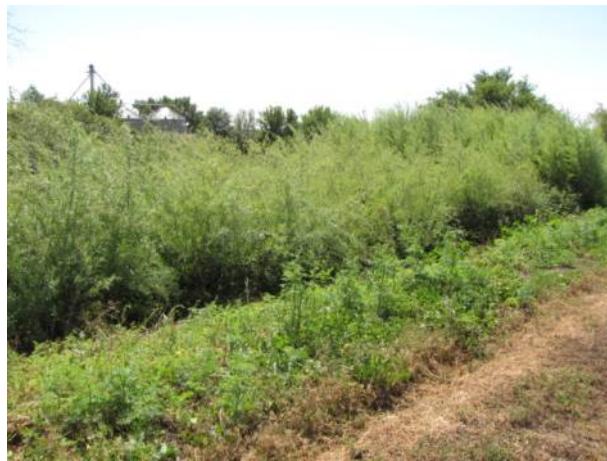
Levee Mile Report Line	58
Start Levee Mile	3.26
End Levee Mile	3.91
Location	Water Side
Category	
Item	Vegetation
This wild growth needs to be controlled, no change since last inspection. Photo taken 4-25-2013.	
phillips_s_20130509_420.JPG

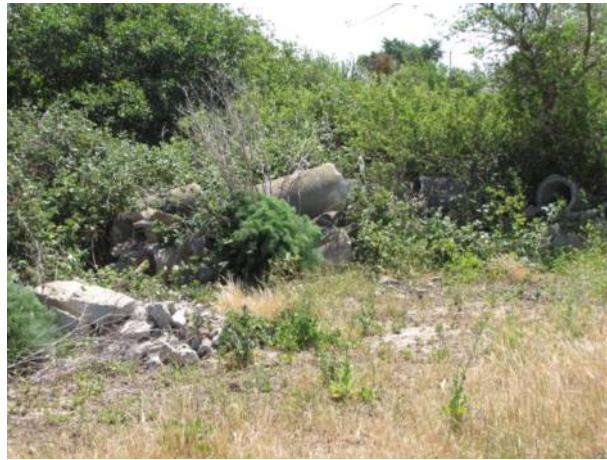
Levee Mile Report Line	61
Start Levee Mile	3.44
End Levee Mile	3.46
Location	Water Side
Category	
Item	Encroachments
Concrete pipe not removed from levee section. Photo taken 4-25-2013.	
phillips_s_20130509_421.JPG

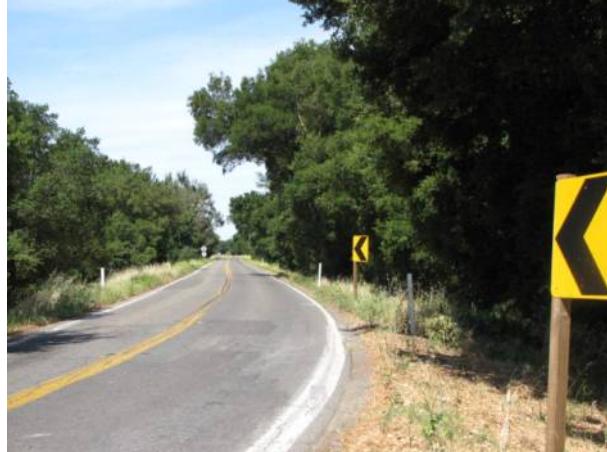
Levee Mile Report Line	1
Start Levee Mile	0.00
End Levee Mile	0.00
Location	Water Side
Category	
Item	Vegetation
RD 556 Unit 2 looking upstream from levee mile 0.00 waterside slope. From this point both waterside and land side are visible. Wild growth present. Photo taken 5-15-2013.	
phillips_s_20130515_434.JPG

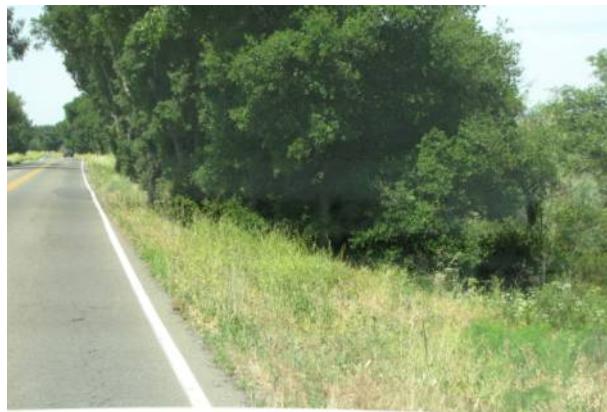
Levee Mile Report Line	4
Start Levee Mile	0.08
End Levee Mile	0.14
Location	Water Side
Category	
Item	Vegetation
RD 556 Water side wild growth on slope and shoulder. Photo taken 4-25-2013.	
phillips_s_20130515_435.JPG

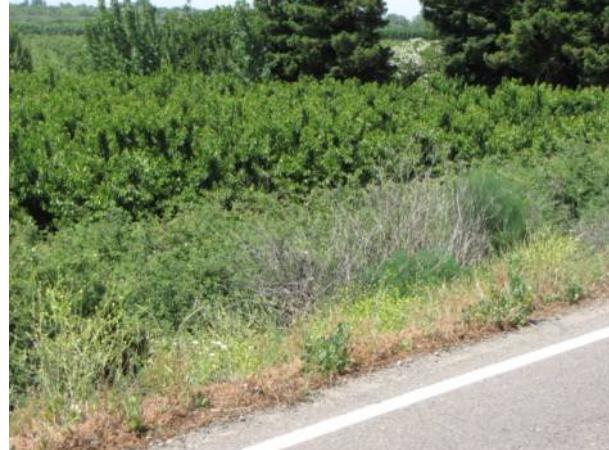
Levee Mile Report Line	18
Start Levee Mile	1.03
End Levee Mile	1.07
Location	Land Side
Category	
Item	Vegetation
Unsatisfactory growth on landward slope and toe of landward levee section. Photo taken 4-25-2013.	
phillips_s_20130516_437.JPG

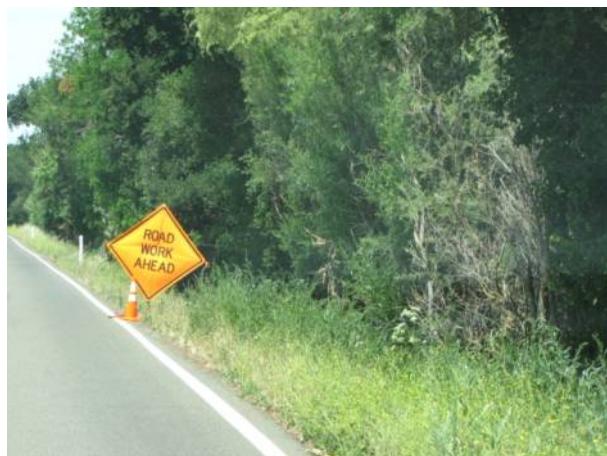
Levee Mile Report Line	21
Start Levee Mile	1.17
End Levee Mile	1.37
Location	Water Side
Category	
Item	Trim / Thin Trees
Unsatisfactory wild growth on landward slope blocking view of levee section. Photo taken 4-25-2013.	
phillips_s_20130521_446.JPG

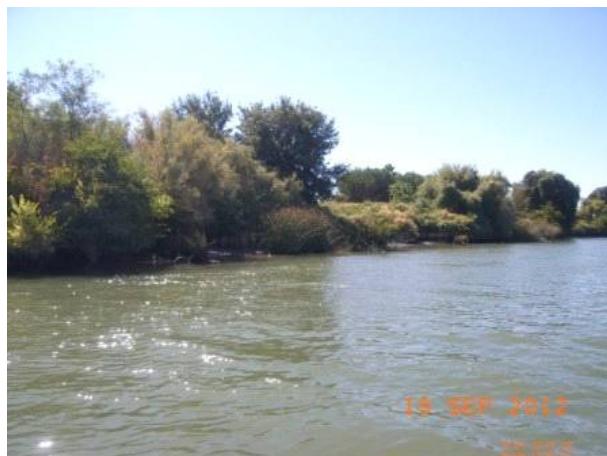
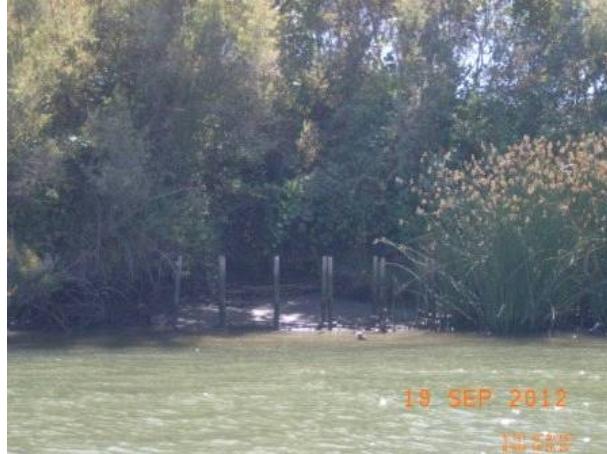
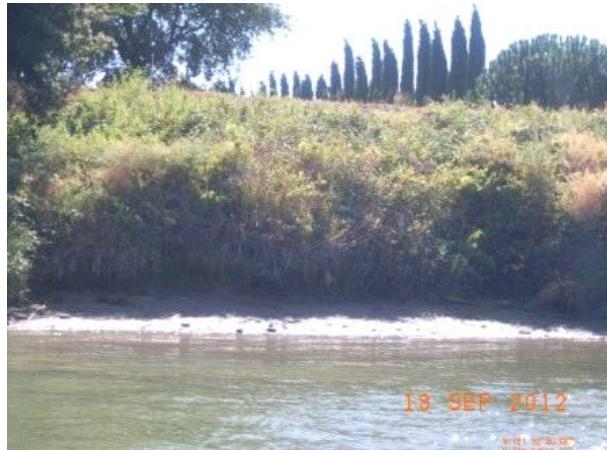
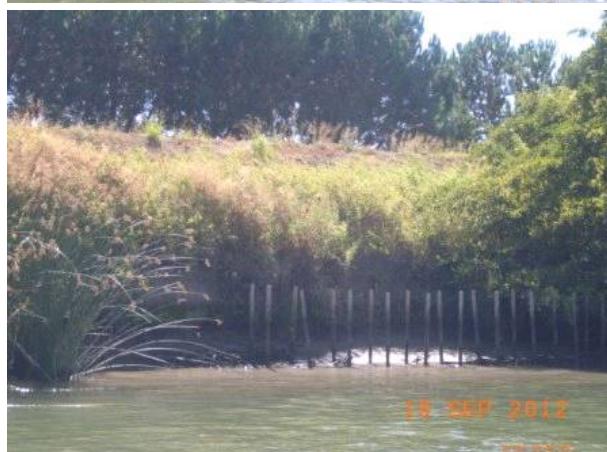
Levee Mile Report Line	22
Start Levee Mile	1.45
End Levee Mile	1.59
Location	Water Side
Category	Supplemental
Item	USACE Erosion Survey
USACE 2012 Photo #1	
phillips_s_20130228_195.jpg

DWR ID: DWR_RD0556_02_s_2013_69	
22	1.45	1.59	Supplemental USACE Erosion Survey	WS M Inspector Comments: 1997 - Slow erosion of the berm at the waterline; bench below water. 2005 - Brush boxes present. 2010 - Minor new erosion. 2012: No observed change. [2012 Site ID: SAC_24-8_L]	Ma		38.240401 °	38.240772 °	23	-121.544106 °	-121.546791 °
										DWR ID: DWR_RD0556_02_s_2013_23	
23	1.45	3.28	Vegetation	LS M V2 : Remove the wild growth other than native grasses from the levee slopes.	Ma		38.240196 °	38.223070 °	50	-121.544292 °	-121.555456 °
										DWR ID: DWR_RD0556_02_f_2012_50	
24	1.52	1.79	Vegetation	WS M V2 : Remove the wild growth other than native grasses from the levee slopes.	Ma		38.240371 °	38.241034 °	70	-121.545463 °	-121.550501 °
										DWR ID: DWR_RD0556_02_s_2013_70	
25	1.53	1.71	Vegetation	LS U V2 : Remove the wild growth other than native grasses from the levee slopes.	Ma		38.240417 °	38.240959 °	71	-121.545769 °	-121.549025 °

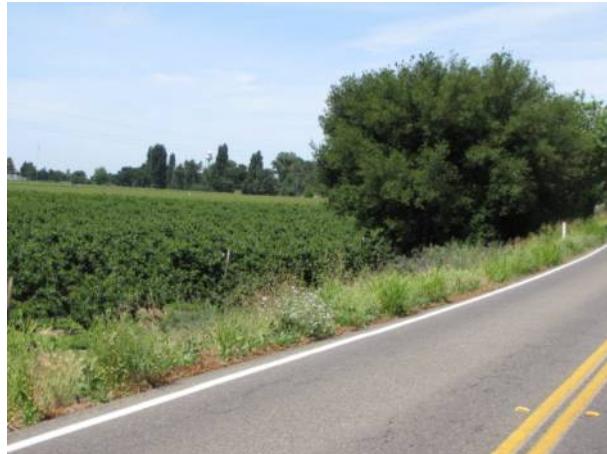
Levee Mile Report Line	25
Start Levee Mile	1.53
End Levee Mile	1.71
Location	Land Side
Category	
Item	Vegetation
Wild growth on landward levee section greater than 4 feet tall covering levee slope. Photo taken 4-25-2013.	
phillips_s_20130521_447.JPG

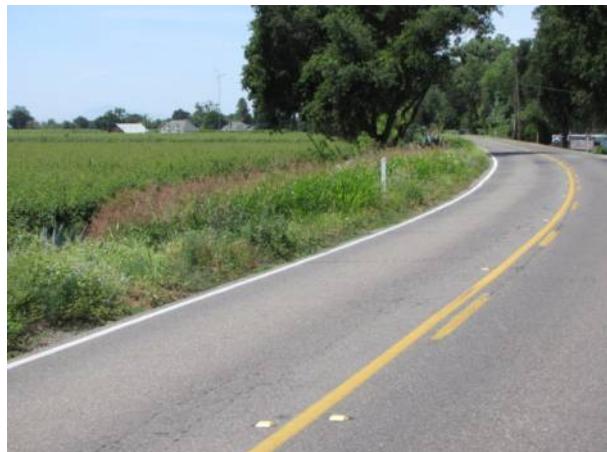
Levee Mile Report Line	27
Start Levee Mile	1.86
End Levee Mile	4.27
Location	Land Side
Category	
Item	Vegetation
This photo captures some of the wild growth on the landward slope and shoulder that stretches for several miles. Only one photo was taken at the beginning of the run. Photo taken 4-25-2013.	
phillips_s_20130521_448.JPG

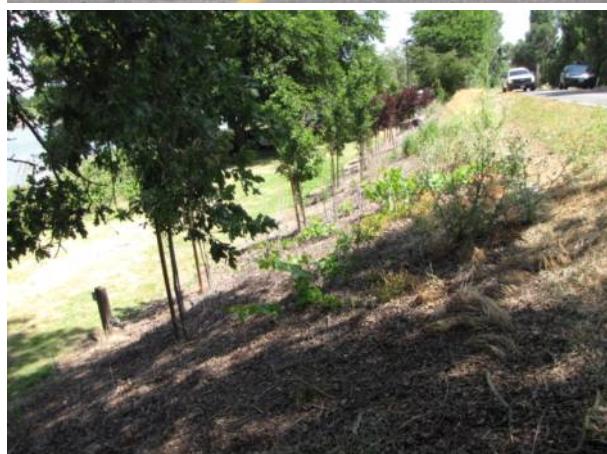
Levee Mile Report Line	32
Start Levee Mile	2.10
End Levee Mile	2.16
Location	Water Side
Category	
Item	Encroachments
Unauthorized tree plantings along the toe waterward levee section looking downstream. Photo taken 4-25-2013.	
phillips_s_20130516_438.JPG

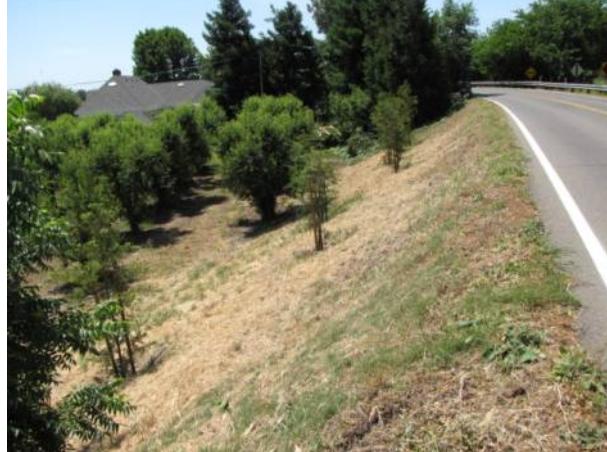
Levee Mile Report Line	33
Start Levee Mile	2.31
End Levee Mile	2.33
Location	Land Side
Category	
Item	Encroachments
Unauthorized young trees planted on the landward slope. Photo taken 4-25-13.	
phillips_s_20130520_441.JPG

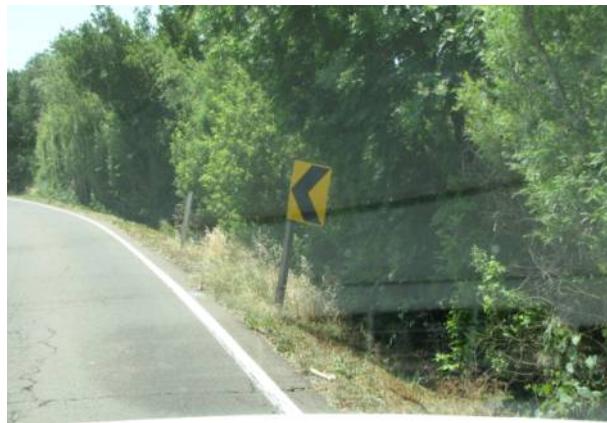
Levee Mile Report Line	34
Start Levee Mile	2.32
End Levee Mile	2.55
Location	Water Side
Category	
Item	Trim / Thin Trees
Unsatisfactory growth of trees blocking view of levee section waterward slope. Photo taken 4-25-2013.	
phillips_s_20130516_439.JPG

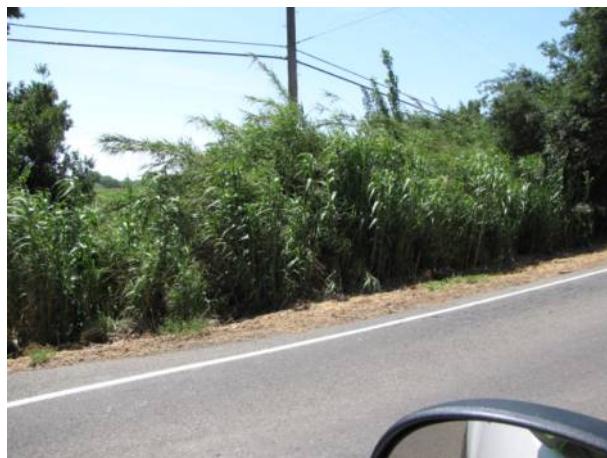
Levee Mile Report Line	35
Start Levee Mile	2.38
End Levee Mile	2.73
Location	Land Side
Category	
Item	Vegetation
RD 556 Unit 2 Bamboo taking over the levee section landward. Photo taken 4-25-2013.	
phillips_s_20130516_440.JPG

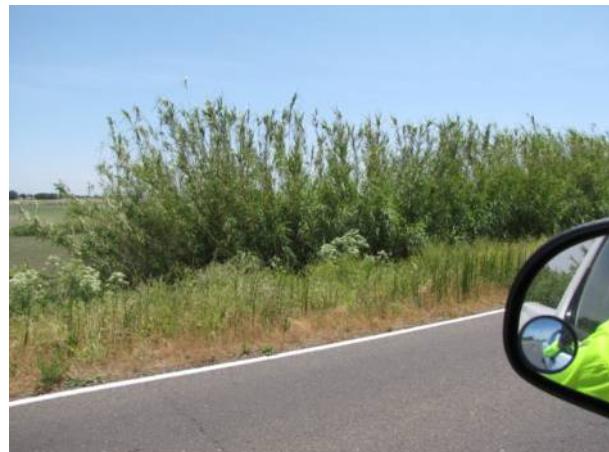
Unsatisfactory wild growth of bamboo on landward slope. Photo taken 4-25-2013.

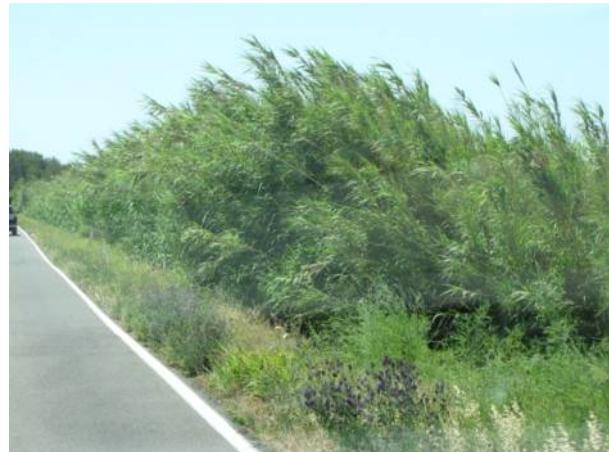
Unsatisfactory wild growth of bamboo blocking view of levee section waterward slope. Photo taken 4-25-2013.

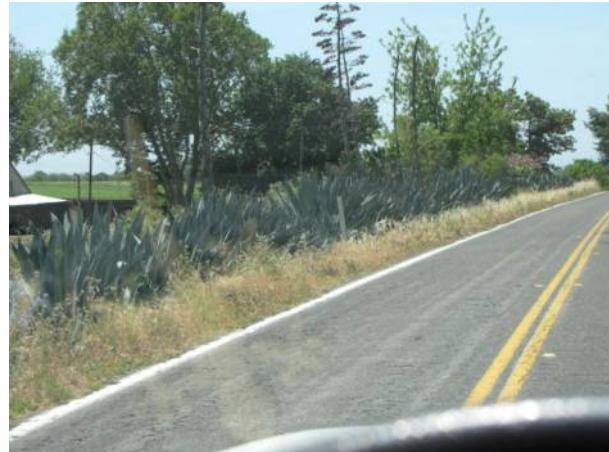
Levee Mile Report Line	58
Start Levee Mile	4.53
End Levee Mile	4.89
Location	Land Side
Category	
Item	Encroachments
Unsatisfactory landscaping blocking slope and shoulder on the landward levee section. Photo taken 4-25-2013.	
phillips_s_20130520_445.JPG

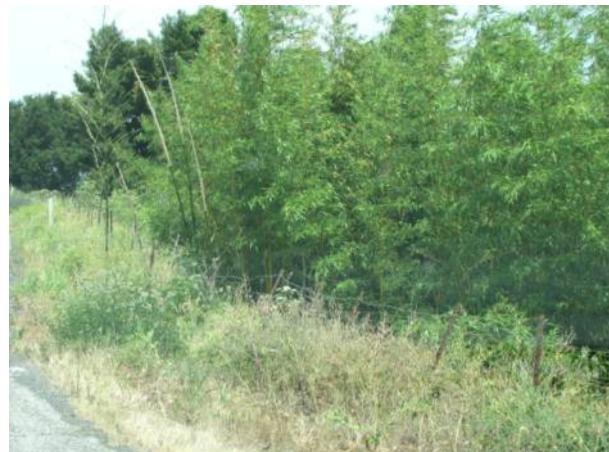
Levee Mile Report Line	62
Start Levee Mile	4.72
End Levee Mile	4.90
Location	Land Side
Category	
Item	Vegetation
Unsatisfactory wild growth on levee section; can't see slope. Photo taken 4-25-2013.	
phillips_s_20130520_444.JPG
